**Flood Control Project Maintenance
Levee Inspections**
LMA District Cover Sheet
Spring 2018 Levee Inspection Results

Reclamation District No. 0999 Netherlands

Spring 2018 Levee Inspection Results

Waterway			Bank	Unit Miles
Unit No. 01 Yolo Bypass			Left	15.41
	Spring (March - May)	Summer (June - August)	(September - November) Fall	Winter (December - February)
Unit Maintenance Rating (Fall Only)				
Date of Inspection	5/8/2018 - 5/8/2018			
DWR Inspector	Dave Torres			
Accompanied By	Tom Slater RD999

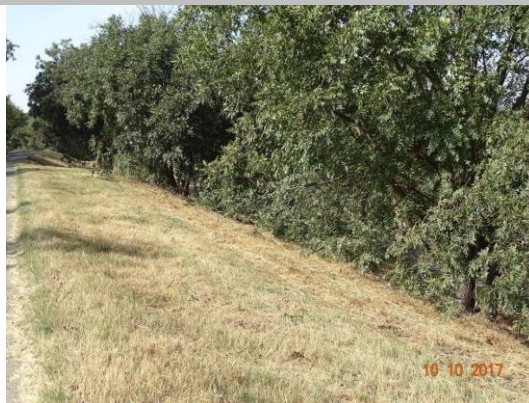
Photo 1 of 2 : SP_2018_RD0999_233_39_20180301_00028.jpg

LM Start	0.96	Rating **	U	Issue No.	39
LM End	1.01	Issue Type +	Ma	Location *	LS
Category	Earthen Levee			GPS Latitude/Longitude	
				Start	End
Item	Trim / Thin Trees			38.291603 °	38.291292 °
				-121.628485 °	-121.627577 °
DWR ID	DWR_RD0999_02_f_2014_39				
Comment Code					
T1 : Trim trees to at least five feet above ground level.					
Inspector Comment					
Untrimmed trees along landside toe.

View of landside slope looking west.

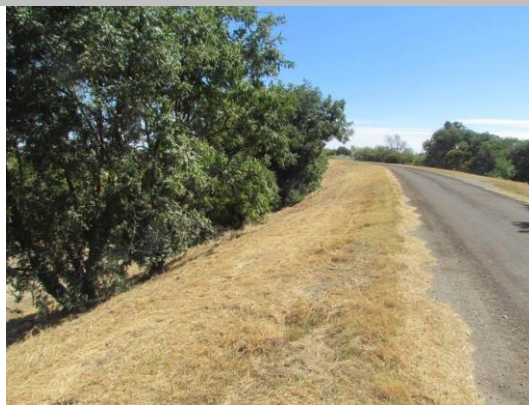
Photo 2 of 2 : SP_2018_RD0999_233_39_20180301_00029.jpg

LM Start	0.96	Rating **	U	Issue No.	39 (cont)
LM End	1.01	Issue Type +	Ma	Location *	LS

Looking east at untrimmed trees on landward slope.

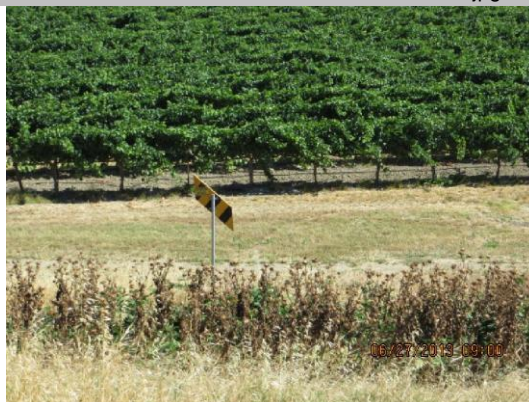
Photo 2 of 3 : UCIP_SP_2018_16331_27515.jpg

LM Start	1.02	Rating **	M	Issue No.	47 (cont)
LM End	1.02	Issue Type +	En	Location *

Gasline marker on LS toe.

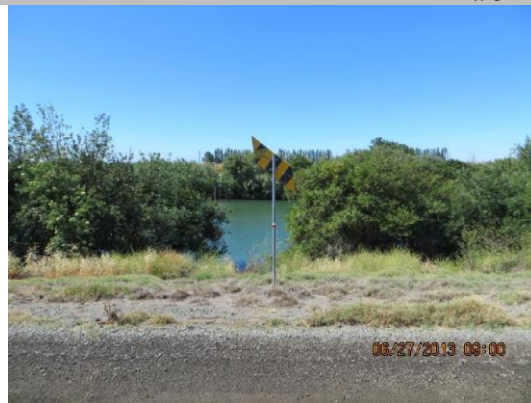
Photo 3 of 3 : UCIP_SP_2018_16331_27514.jpg

LM Start	1.02	Rating **	M	Issue No.	47 (cont)	
LM End	1.02	Issue Type +	En	Location *		
Category	Supplemental			GPS Latitude/Longitude		
				Start		End
Item	DWR UCIP Field Study			38.291252 °		38.291252 °
				-121.627398 °		-121.627398 °
DWR ID						
Comment Code						
Inspector Comment						
FS_ID:16331 DS_ID:23961 EP_NO: N/A Repair Type: Non-Urgent Crossing Status: Found UCIP Comments: Need to determine permit for this crossing. FIELD_STRUCT_DESC: Gas line through the levee at an unknown depth. Markers on both shoulders. FS Date: 6/27/2013

Gasline marker on WS shoulder.

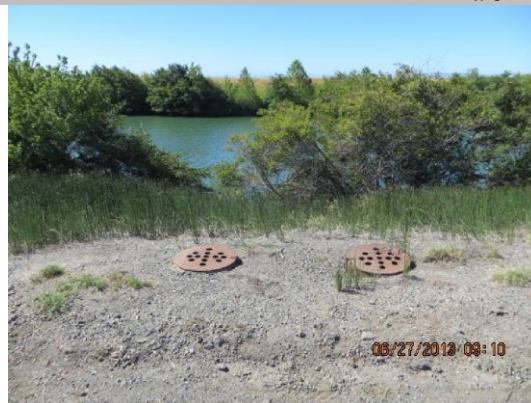
Photo 1 of 3 : UCIP_SP_2018_16333_27523.jpg

LM Start	1.25	Rating **	M	Issue No.	48
LM End	1.25	Issue Type +	En	Location *	
Category	Supplemental			GPS Latitude/Longitude	
				Start	End
Item	DWR UCIP Field Study			38.291379 °	38.291379 °
				-121.623285 °	-121.623285 °
DWR ID					
Comment Code					
Inspector Comment					
FS_ID:16333 DS_ID:23962 EP_NO: N/A Repair Type: Non-Urgent Crossing Status: Found UCIP Comments: Need to determine permit for this crossing. FIELD_STRUCT_DESC: 16-inch coated steel drainage pipe through the levee, 3 feet below the crown. Pump in a pump house on the landside (LS) toe. Siphon breaker in a 24-inch steel riser on the waterside (WS). (Permit No. 17064, 1999 - Reclamation District No. 999). FS Date: 6/27/2013

Siphon breaker on WS shoulder.

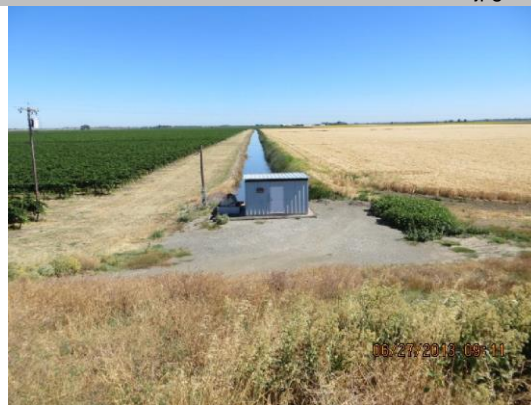
Photo 2 of 3 : UCIP_SP_2018_16333_27522.jpg

LM Start	1.25	Rating **	M	Issue No.	48 (cont)
LM End	1.25	Issue Type +	En	Location *

Pumphouse off LS toe.

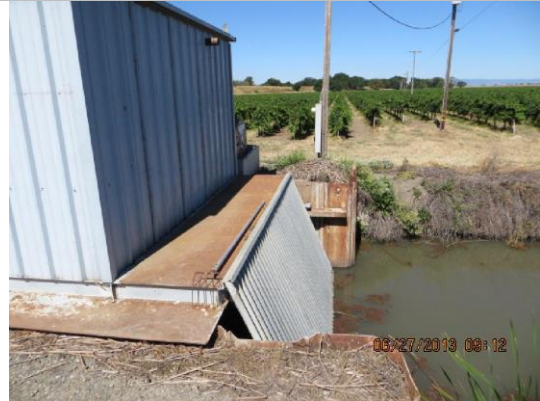
Photo 3 of 3 : UCIP_SP_2018_16333_27521.jpg

LM Start	1.25	Rating **	M	Issue No.	48 (cont)	
LM End	1.25	Issue Type +	En	Location *		
Category	Supplemental			GPS Latitude/Longitude		
				Start	End	
Item	DWR UCIP Field Study			38.291379 °	38.291379 °	
				-121.623285 °	-121.623285 °	
DWR ID						
Comment Code						
Inspector Comment						
FS_ID:16333						
DS_ID:23962						
EP_NO: N/A						
Repair Type: Non-Urgent						
Crossing Status: Found						
UCIP Comments: Need to determine permit for this crossing.						
FIELD_STRUCT_DESC: 16-inch coated steel drainage pipe through						
the levee, 3 feet below the crown. Pump in a pump house on the						
landside (LS) toe. Siphon breaker in a 24-inch steel riser on the						
waterside (WS). (Permit No. 17064, 1999 - Reclamation District No.						
999).						
FS Date: 6/27/2013

Trash rack on Pumphouse off LS toe.

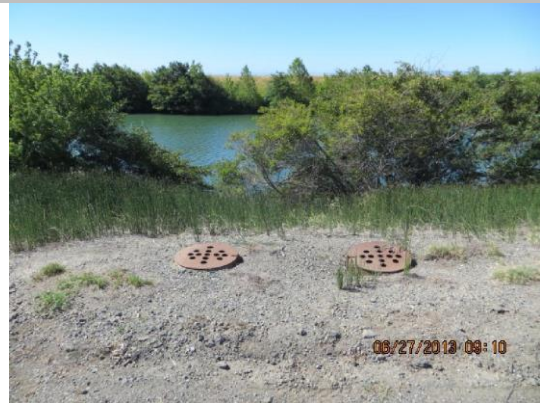
Photo 1 of 3 : UCIP_SP_2018_16334_27527.jpg

LM Start	1.25	Rating **	M	Issue No.	49	
LM End	1.25	Issue Type +	En	Location *		
Category	Supplemental			GPS Latitude/Longitude		
				Start	End	
Item	DWR UCIP Field Study			38.291381 °	38.291381 °	
				-121.623268 °	-121.623268 °	
DWR ID						
Comment Code						
Inspector Comment						
FS_ID:16334						
DS_ID:23963						
EP_NO: N/A						
Repair Type: Non-Urgent						
Crossing Status: Found						
UCIP Comments: Need to determine permit No. for this crossing.						
FIELD_STRUCT_DESC: 30-inch coated steel drainage pipe through						
the levee, 2.5 feet below the crown. Pump in a pump house on the						
landside (LS) toe. Siphon breaker in a 24-inch steel riser on the						
waterside (WS). (Permit No. 17064, 1999 - Reclamation District No.						
999).						
FS Date: 6/27/2013

Siphon breaker on WS shoulder.

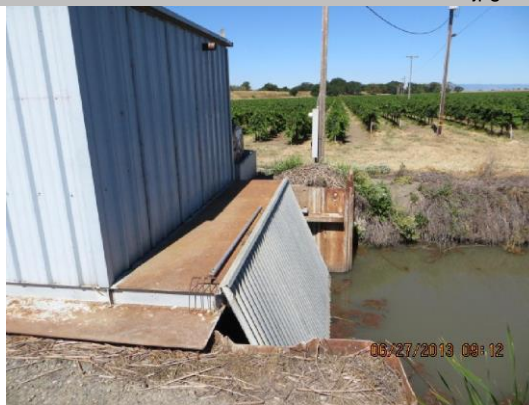
Photo 3 of 3 : UCIP_SP_2018_16334_27525.jpg

LM Start	1.25	Rating **	M	Issue No.	49 (cont)
LM End	1.25	Issue Type +	En	Location *

Pumphouse on LS toe with trash rack.

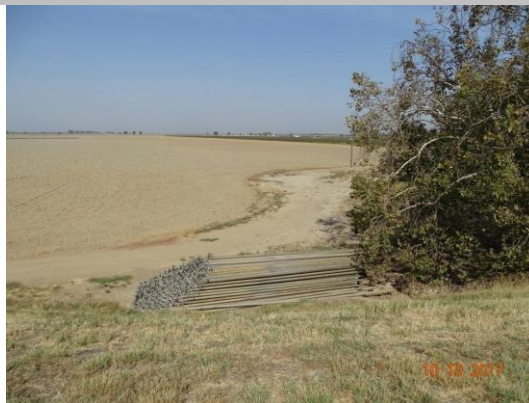
Photo 1 of 1 : SP_2018_RD0999_233_27_20180301_00021.jpg

LM Start	1.66	Rating **	M	Issue No.	27
LM End	1.66	Issue Type +	En	Location *	LS
Category	Earthen Levee			GPS Latitude/Longitude	
				Start	End
Item	Encroachments			38.290376 °	38.290376 °
				-121.615848 °	-121.615848 °
DWR ID	DWR_RD0999_02_f_2017_27				
Comment Code					
PI : Pipe					
Inspector Comment					
Pipes stored at the landside toe.

View of landside slope looking north.

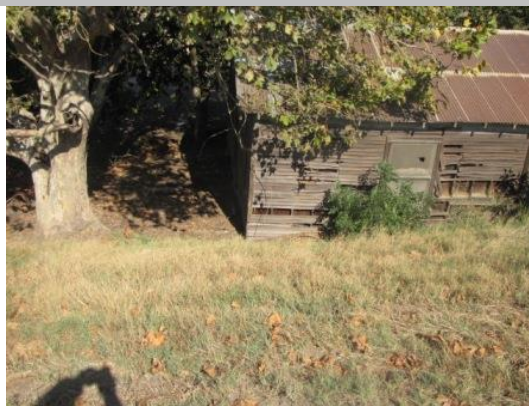
Photo 1 of 2 : SP_2018_RD0999_233_3_20180301_00002.jpg

LM Start	1.67	Rating **	U	Issue No.	3
LM End	1.68	Issue Type +	En	Location *	LS
Category	Earthen Levee			GPS Latitude/Longitude	
				Start	End
Item	Encroachments			38.290287 °	38.290217 °
				-121.615668 °	-121.615460 °
DWR ID	DWR_RD0999_02_s_2012_3				
Comment Code					
BU : Building					
Inspector Comment					
Old storage shed on landside toe and berm.

Looking Norht at building at landside toe.

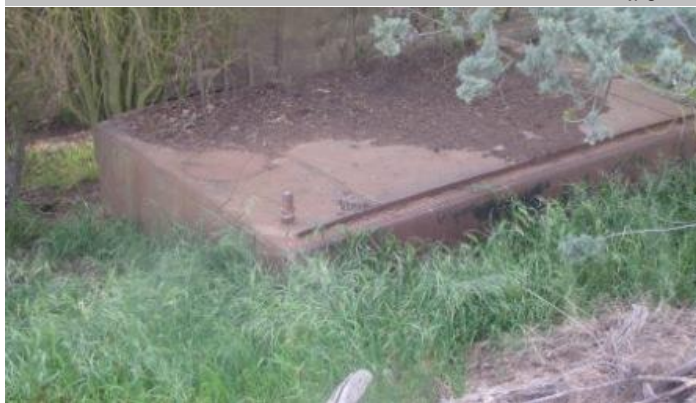
Photo 1 of 1 : SP_2018_RD0999_233_10_20180301_00007.jpg

LM Start	1.69	Rating **	U	Issue No.	10
LM End	1.69	Issue Type +	En	Location *	LS
Category	Earthen Levee			GPS Latitude/Longitude	
				Start	End
Item	Encroachments			38.290195 °	38.290195 °
				-121.615268 °	-121.615268 °
DWR ID	DWR_RD0999_02_s_2012_10				
Comment Code					
TA : Tank					
Inspector Comment

Looking north at a tank on the landside slope and toe.

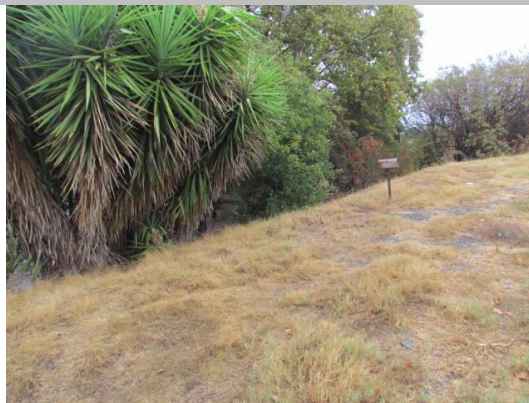
Photo 1 of 2 : SP_2018_RD0999_233_11_20180301_00008.jpg

LM Start	1.70	Rating **	U	Issue No.	11
LM End	1.70	Issue Type +	En	Location *	LS
Category	Earthen Levee			GPS Latitude/Longitude	
				Start	End
Item	Vegetation			38.290171 °	38.290171 °
				-121.615260 °	-121.615260 °
DWR ID	DWR_RD0999_02_s_2012_11				
Comment Code					
V6 : Landscaping					
Inspector Comment

Looking at dense trees on landward slope.

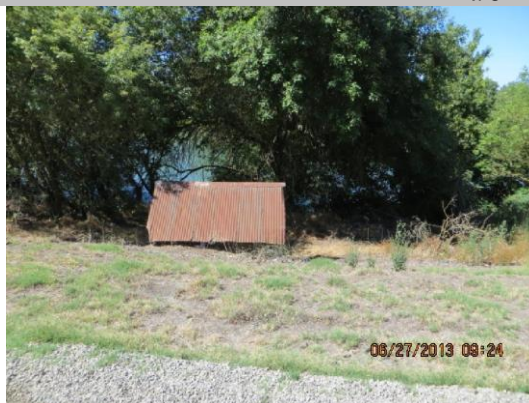
Photo 1 of 3 : UCIP_SP_2018_15386_25249.jpg

LM Start	1.72	Rating **	M	Issue No.	50
LM End	1.72	Issue Type +	En	Location *	
Category	Supplemental			GPS Latitude/Longitude	
				Start	End
Item	DWR UCIP Field Study			38.289967 °	38.289967 °
				-121.614873 °	-121.614873 °
DWR ID					
Comment Code					
Inspector Comment					
FS_ID:15386 DS_ID:22774 EP_NO: N/A Repair Type: Non-Urgent Crossing Status: Found UCIP Comments: Pipe abandoned and should be done so properly. FIELD_STRUCT_DESC: *ABANDONED* 10-inch steel drainage pipe through the levee, 8.3 feet below the crown. 6-foot by 11-foot corrugated metal pump house and gate valve on the waterside (WS) slope. 36-inch concrete standpipe on the landside (LS) toe. [Additional Reference(s): DWR Levee Log, 1992. USACE Sacramento O&M Manual 113 (Revised), October 1966, (HLM 1.72)]. FS Date: 6/27/2013

Pumphouse on WS slope.

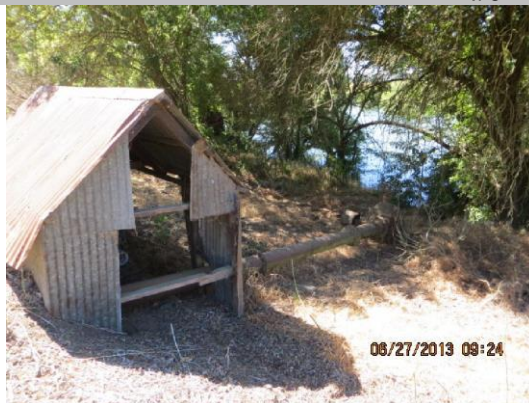
Photo 2 of 3 : UCIP_SP_2018_15386_25248.jpg

LM Start	1.72	Rating **	M	Issue No.	50 (cont)	
LM End	1.72	Issue Type +	En	Location *		
Category	Supplemental			GPS Latitude/Longitude		
				Start	End	
Item	DWR UCIP Field Study			38.289967 °	38.289967 °	
				-121.614873 °	-121.614873 °	
DWR ID						
Comment Code						
Inspector Comment						
FS_ID:15386 DS_ID:22774 EP_NO: N/A Repair Type: Non-Urgent Crossing Status: Found UCIP Comments: Pipe abandoned and should be done so properly. FIELD_STRUCT_DESC: *ABANDONED* 10-inch steel drainage pipe through the levee, 8.3 feet below the crown. 6-foot by 11-foot corrugated metal pump house and gate valve on the waterside (WS) slope. 36-inch concrete standpipe on the landside (LS) toe. [Additional Reference(s): DWR Levee Log, 1992. USACE Sacramento O&M Manual 113 (Revised), October 1966, (HLM 1.72)]. FS Date: 6/27/2013

Pipe, pumphouse, and gate valve on WS slope.

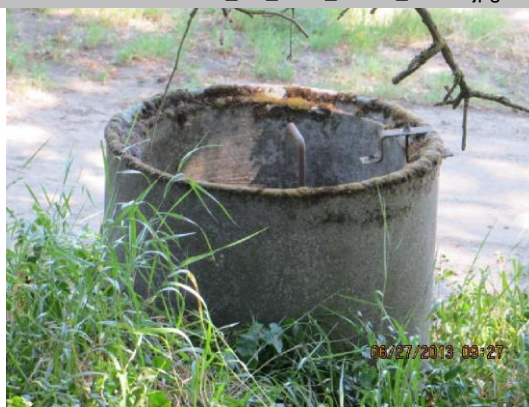
Photo 3 of 3 : UCIP_SP_2018_15386_25247.jpg

Concrete standpipe on LS toe.

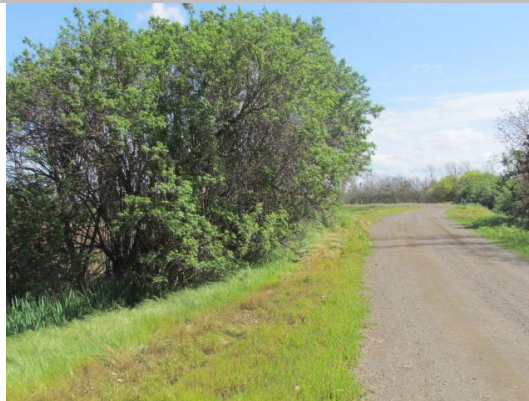
Photo 1 of 3 : SP_2018_RD0999_233_8_20180301_00004.jpg

LM Start	1.73	Rating **	M	Issue No.	8
LM End	1.76	Issue Type +	En	Location *	LS
Category	Earthen Levee			GPS Latitude/Longitude	
				Start	End
Item	Vegetation			38.289895 °	38.289595 °
				-121.614688 °	-121.614337 °
DWR ID	DWR_RD0999_02_s_2012_8				
Comment Code					
V6 : Landscaping					
Inspector Comment

Looking east at dense vegetation on landward shoulder and slope.
(Spring 2016)

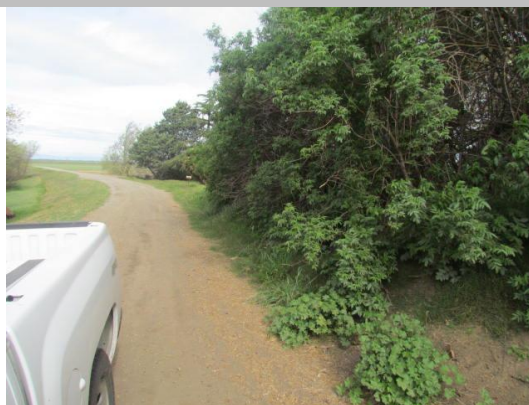
Photo 2 of 3 : SP_2018_RD0999_233_8_20180301_00005.jpg

Looking west at dense vegetation on landward shoulder and slope.
(Spring 2015)

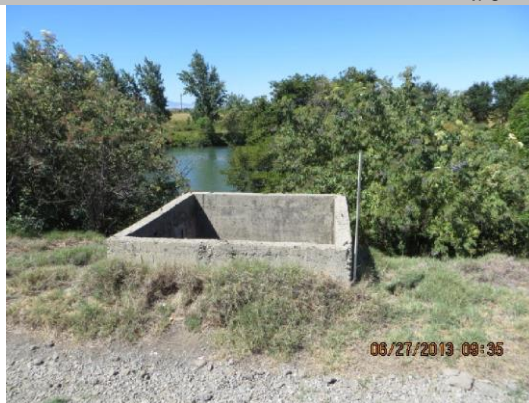
Photo 1 of 2 : UCIP_SP_2018_41069_25251.jpg

LM Start	1.78	Rating **	M	Issue No.	51
LM End	1.78	Issue Type +	En	Location *	
Category	Supplemental			GPS Latitude/Longitude	
				Start	End
Item	DWR UCIP Field Study			38.289357 °	38.289357 °
				-121.614089 °	-121.614089 °
DWR ID					
Comment Code					
Inspector Comment					
FS_ID:41069 DS_ID:22775 EP_NO: N/A Repair Type: Non-Urgent Crossing Status: Indicator Found UCIP Comments: Appears abandoned. FIELD_STRUCT_DESC: 8-inch steel irrigation pipe through the levee, 4 feet below the crown. Used during irrigation season with a portable pump. 7-foot by 7-foot concrete pump house sump on the waterside (WS) shoulder with pump mount. [Additional Reference(s): DWR Levee Log, 1992. USACE Sacramento O&M Manual 113 (Revised), October 1966, (HLM 1.78)]. FS Date: 6/27/2013

7'X7' concrete pumphouse sump on WS shoulder.

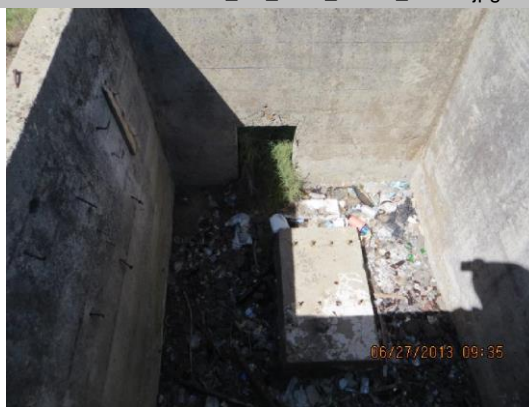
Photo 2 of 2 : UCIP_SP_2018_41069_25250.jpg

Pump mount inside foundation at WS slope.

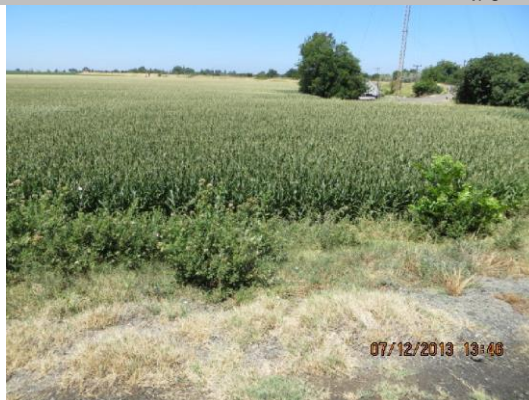
Photo 1 of 3 : UCIP_SP_2018_15703_26125.jpg

LM Start	2.28	Rating **	M	Issue No.	52
LM End	2.28	Issue Type +	En	Location *	
Category	Supplemental			GPS Latitude/Longitude	
				Start	End
Item	DWR UCIP Field Study			38.286666 °	38.286666 °
				-121.606803 °	-121.606803 °
DWR ID					
Comment Code					
Inspector Comment					
FS_ID:15703 DS_ID:22770 EP_NO: 3855 Repair Type: Non-Urgent Crossing Status: Found UCIP Comments: Pipe not capped on LS and not found on WS. FIELD_STRUCT_DESC: 10-inch steel irrigation pipe through the levee, 4 feet below the crown. Capped during winter months. 6-inch pipe sleeved through the 10-inch pipe during irrigation season. (Permit No. 3855, 1962 - K. Barsoom). [Additional Reference(s): DWR Levee Log, 1992. USACE Sacramento O&M Manual 113 (Revised), October 1966, (HLM 2.31)]. FS Date: 6/27/2013

Pipe visible just off shoulder on LS slope in the rose bushes.

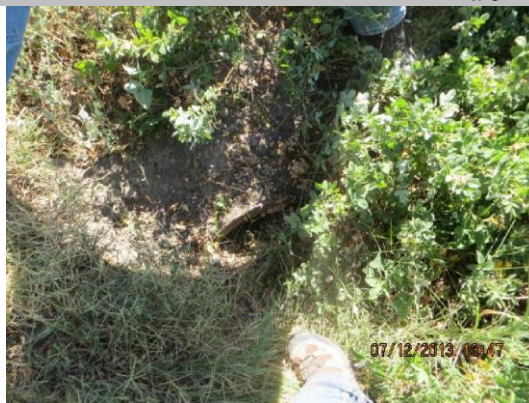
Photo 2 of 3 : UCIP_SP_2018_15703_26124.jpg

Pipe visible just off shoulder on LS slope in the rose bushes.

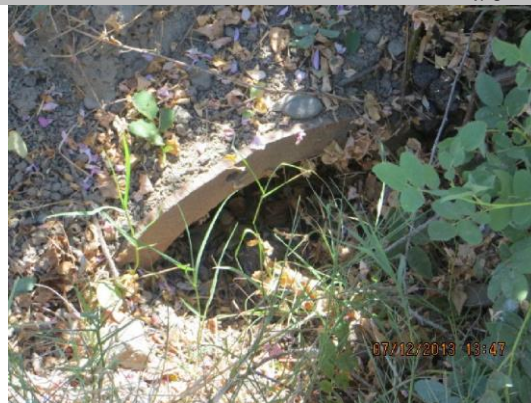
Photo 3 of 3 : UCIP_SP_2018_15703_26123.jpg

LM Start	2.28	Rating **	M	Issue No.	52 (cont)	
LM End	2.28	Issue Type +	En	Location *		
Category	Supplemental			GPS Latitude/Longitude		
				Start	End	
Item	DWR UCIP Field Study			38.286666 °	38.286666 °	
				-121.606803 °	-121.606803 °	
DWR ID						
Comment Code						
Inspector Comment						
FS_ID:15703 DS_ID:22770 EP_NO: 3855 Repair Type: Non-Urgent Crossing Status: Found UCIP Comments: Pipe not capped on LS and not found on WS. FIELD_STRUCT_DESC: 10-inch steel irrigation pipe through the levee, 4 feet below the crown. Capped during winter months. 6-inch pipe sleeved through the 10-inch pipe during irrigation season. (Permit No. 3855, 1962 - K. Barsoom). [Additional Reference(s): DWR Levee Log, 1992. USACE Sacramento O&M Manual 113 (Revised), October 1966, (HLM 2.31)]. FS Date: 6/27/2013

Pipe partially filled with soil and open on LS.

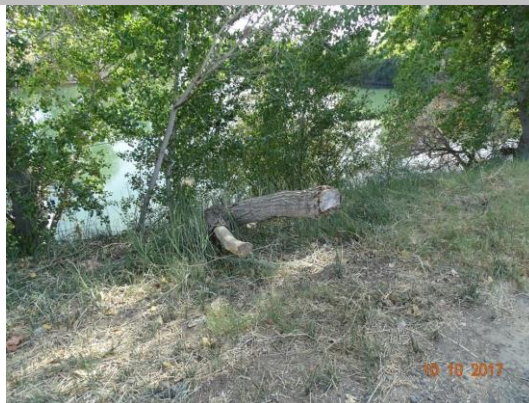
Photo 1 of 1 : SP_2018_RD0999_234_16_20180301_00017.jpg

LM Start	0.01	Rating **	M	Issue No.	16
LM End	0.01	Issue Type +	Ma	Location *	WS
Category	Earthen Levee			GPS Latitude/Longitude	
				Start	End
Item	Encroachments			38.286678 °	38.286678 °
				-121.605971 °	-121.605971 °
DWR ID	DWR_RD0999_03_f_2017_16				
Comment Code					
TR : Tree or limb					
Inspector Comment

View of waterside slope looking east.

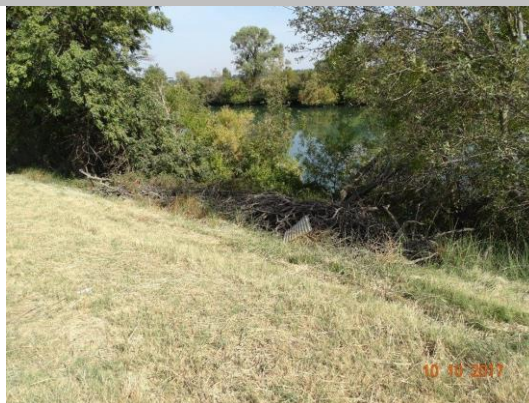
Photo 1 of 1 : SP_2018_RD0999_234_32_20180301_00033.jpg

LM Start	0.04	Rating **	M	Issue No.	32
LM End	0.04	Issue Type +	Ma	Location *	WS
Category	Earthen Levee			GPS Latitude/Longitude	
				Start	End
Item	Encroachments			38.287040 °	38.287040 °
				-121.605667 °	-121.605667 °
DWR ID	DWR_RD0999_03_f_2017_32				
Comment Code					
PR : Prunings					
Inspector Comment					
Large pruning pile on waterside slope.

View of waterside slope looking east.

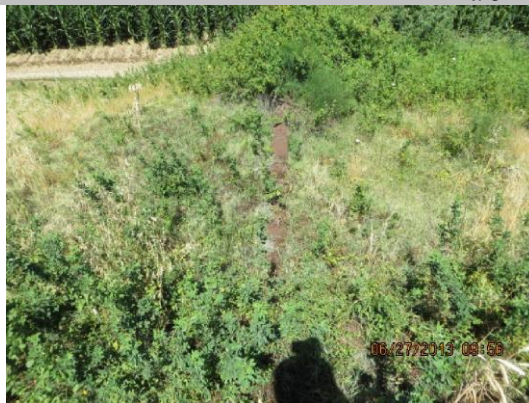
Photo 2 of 3 : UCIP_SP_2018_15389_25253.jpg

LM Start	0.18	Rating **	M	Issue No.	44 (cont)	
LM End	0.18	Issue Type +	En	Location *		
Category	Supplemental			GPS Latitude/Longitude		
				Start		End
Item	DWR UCIP Field Study			38.288813 °		38.288813 °
				-121.604670 °		-121.604670 °
DWR ID						
Comment Code						
Inspector Comment						
FS_ID:15389 DS_ID:22776 EP_NO: N/A Repair Type: Non-Urgent Crossing Status: Found UCIP Comments: Pipe abandoned and should be done so properly. FIELD_STRUCT_DESC: *ABANDONED* 10-inch steel irrigation pipe through the levee, 6.2 feet below the crown. Abandoned 4-foot by 7-foot concrete pump house and gate valve on the landside (LS) slope. Plate welded on the waterside (WS) end. [Additional Reference(s): DWR Levee Log, 1992. USACE Sacramento O&M Manual 113 (Revised), October 1966, (HLM 0.17)]. FS Date: 6/27/2013

Pipe visible on LS slope.

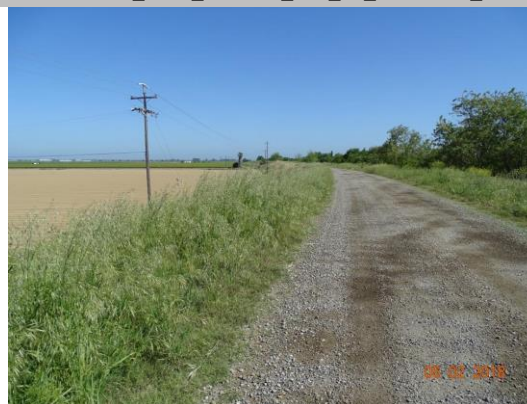
Photo 1 of 1 : SP_2018_RD0999_234_35_20180507_00050.jpg

LM Start	0.22	Rating **	U	Issue No.	35
LM End	0.29	Issue Type +	Ma	Location *	LS
Category	Earthen Levee		GPS Latitude/Longitude		
			Start	End	
Item	Vegetation		38.289427 °	38.290416 °	
			-121.604544 °	-121.604545 °	
DWR ID	DWR_RD0999_03_s_2018_35				
Comment Code					
V1 : Control annual grass and weeds on the levee slopes and easements.					
Inspector Comment

Vegetation landside looking north.

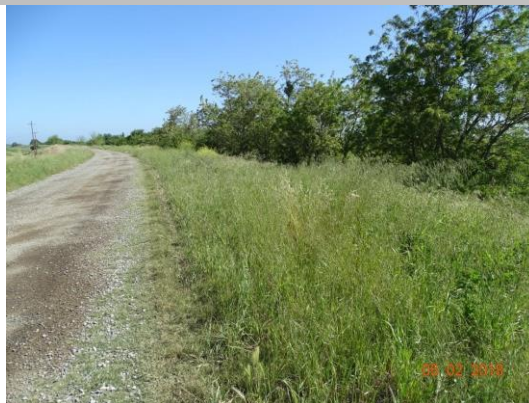
Photo 1 of 1 : SP_2018_RD0999_234_36_20180507_00051.jpg

LM Start	0.22	Rating **	U	Issue No.	36
LM End	0.29	Issue Type +	Ma	Location *	WS
Category	Earthen Levee			GPS Latitude/Longitude	
				Start	End
Item	Vegetation			38.289427 °	38.290416 °
				-121.604544 °	-121.604545 °
DWR ID	DWR_RD0999_03_s_2018_36				
Comment Code					
V1 : Control annual grass and weeds on the levee slopes and easements.					
Inspector Comment

Vegetation waterside looking north.

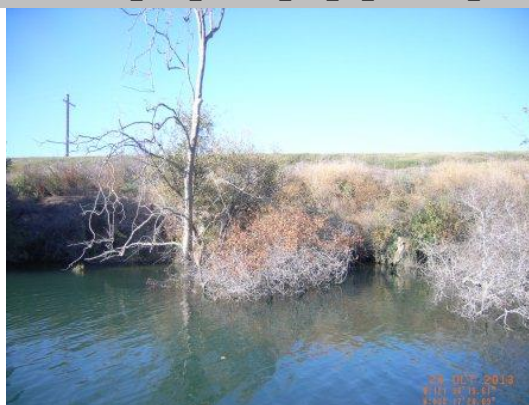
Photo 1 of 1 : SP_2018_RD0999_234_29_20180301_00029.jpg

LM Start	0.24	Rating **	U	Issue No.	29
LM End	0.65	Issue Type +	Ma	Location *	WS
Category	Supplemental			GPS Latitude/Longitude	
				Start	End
Item	2015 USACE Erosion Survey, DRAFT			38.289634 °	38.295505 °
				-121.604343 °	-121.605648 °
DWR ID	DWR_RD0999_03_s_2016_29

Comment Code					
Inspector Comment					
1997 - Intermittent over-steepened sections. Large riparian vegetation along the length of the entire reach. Attempts to repair with rock on bank have failed. 1999 - New rock repair at the downstream end. 2002 - Some minor spot repairs. 2009 - Minimal new erosion. 2010 - Appears that fresh rock placed on downstream portion of site. Toe scour and overhanging trees with some overturned. 2012 - Minor new erosion at the toe. 2013 - Site upgraded to CRITICAL. Severe slumping into levee at downstream end of site. Fresh erosion into bank toe. 2015: New slumping, tall vertical sections. [2015 Site ID: STR_24-7_R]

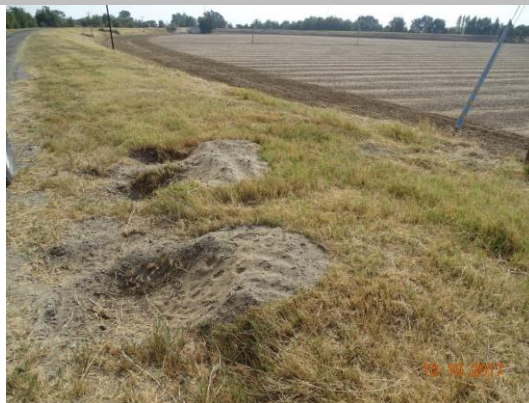
Photo 1 of 1 : SP_2018_RD0999_234_33_20180301_00034.jpg

LM Start	0.38	Rating **	M	Issue No.	33
LM End	0.38	Issue Type +	Ma	Location *	LS
Category	Earthen Levee			GPS Latitude/Longitude	
				Start	End
Item	Slope Stability			38.291640 °	38.291640 °
				-121.604799 °	-121.604799 °
DWR ID	DWR_RD0999_03_f_2017_33				
Comment Code					
S3 : Repair the levee slope damaged by vehicle traffic and prevent access where possible.					
Inspector Comment

View of landside slope looking southwest.

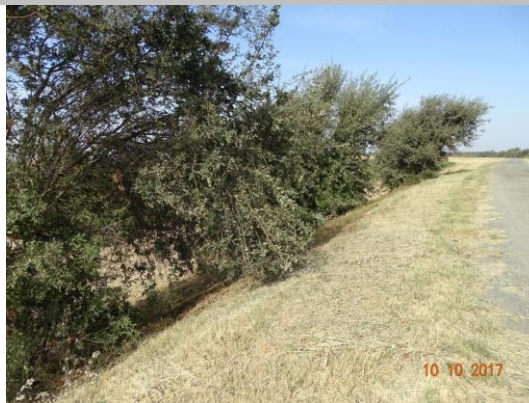
Photo 1 of 2 : SP_2018_RD0999_234_43_20180301_00035.jpg

LM Start	0.93	Rating **	M	Issue No.	43
LM End	0.95	Issue Type +	Ma	Location *	LS
Category	Earthen Levee			GPS Latitude/Longitude	
				Start	End
Item	Trim / Thin Trees			38.299130 °	38.299362 °
				-121.603768 °	-121.603462 °
DWR ID	DWR_RD0999_03_f_2014_43				
Comment Code					
T1 : Trim trees to at least five feet above ground level.					
Inspector Comment

View of landside slope looking northeast.

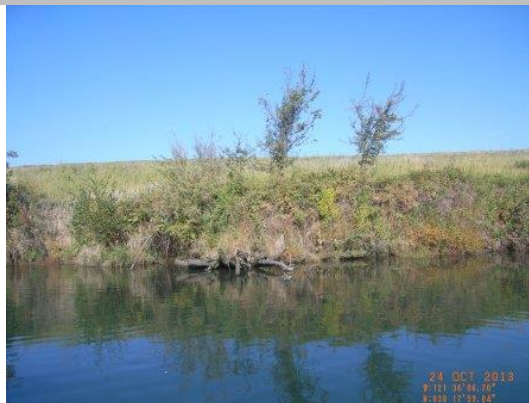
Photo 1 of 1 : SP_2018_RD0999_234_30_20180301_00030.jpg

LM Start	0.97	Rating **	M	Issue No.	30
LM End	1.10	Issue Type +	Ma	Location *	WS
Category	Supplemental			GPS Latitude/Longitude	
				Start	End
Item	2015 USACE Erosion Survey, DRAFT			38.299402 °	38.300542 °
				-121.603056 °	-121.601118 °
DWR ID	DWR_RD0999_03_s_2016_30				
Comment Code					
Inspector Comment					
2008 - Over steepened levee section. 2009 - Significant new erosion. 2010 - Minor new erosion. 2015: No observed changes. [2015 Site ID: STR_25-2_R]

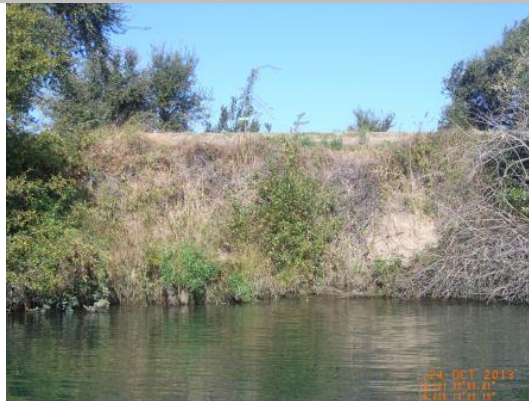
Photo 1 of 1 : SP_2018_RD0999_234_1_20180301_00001.jpg

LM Start	1.43	Rating **	M	Issue No.	1
LM End	1.58	Issue Type +	Ma	Location *	WS
Category	Supplemental			GPS Latitude/Longitude	
				Start	End
Item	2015 USACE Erosion Survey, DRAFT			38.305229 °	38.306667 °
				-121.599933 °	-121.598266 °
DWR ID	DWR_RD0999_03_s_2016_1				
Comment Code					
Inspector Comment					
2011 - Toe scour along length of site and erosion pockets. 2012 - Site extended slighty upstream due to new erosion pocket. 2013 - Tall vertical sections at upstream end of site. 2015: No observed changes. [2015 Site ID: STR_25-7_R]

USACE 2013 Photo #1

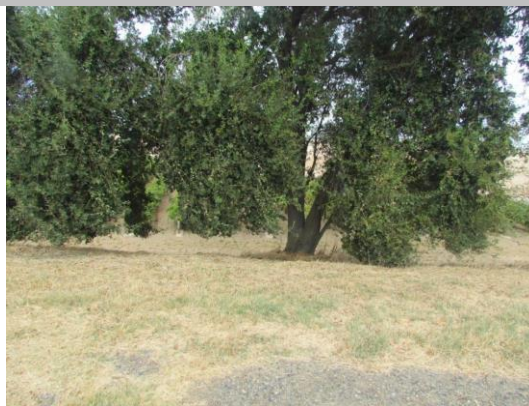
Photo 1 of 2 : SP_2018_RD0999_234_11_20180301_00010.jpg

Looking at untrimmed trees on landward slope and toe. (Fall 2016)

LM Start	1.50	Rating **	M	Issue No.	11
LM End	1.50	Issue Type +	Ma	Location *	LS
Category	Earthen Levee			GPS Latitude/Longitude	
				Start	End
Item	Trim / Thin Trees			38.306062 °	38.306062 °
				-121.599495 °	-121.599495 °
DWR ID	DWR_RD0999_03_s_2012_11				
Comment Code					
T1 : Trim trees to at least five feet above ground level.					
Inspector Comment

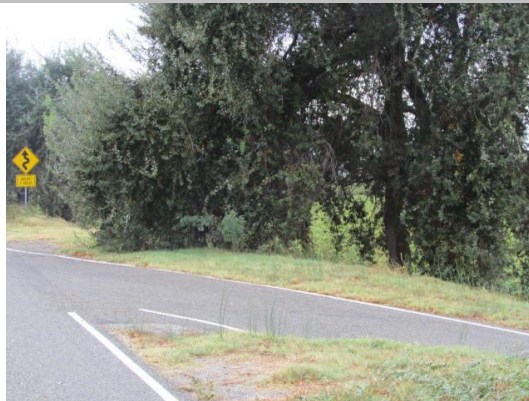
Photo 2 of 2 : SP_2018_RD0999_234_11_20180301_00011.jpg

Looking at untrimmed trees on landward slope and toe. (Spring 2016)

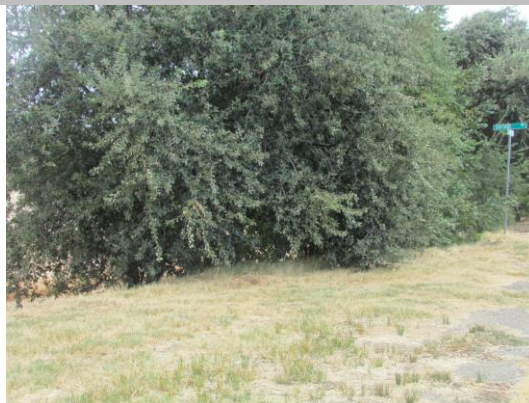
Photo 1 of 1 : SP_2018_RD0999_234_12_20180301_00012.jpg

Looking east at untrimmed trees on landward slope.

LM Start	1.53	Rating **	U	Issue No.	12
LM End	1.53	Issue Type +	Ma	Location *	LS
Category	Earthen Levee			GPS Latitude/Longitude	
				Start	End
Item	Trim / Thin Trees			38.306332 °	38.306332 °
				-121.599109 °	-121.599109 °
DWR ID	DWR_RD0999_03_s_2012_12				
Comment Code					
T1 : Trim trees to at least five feet above ground level.					
Inspector Comment

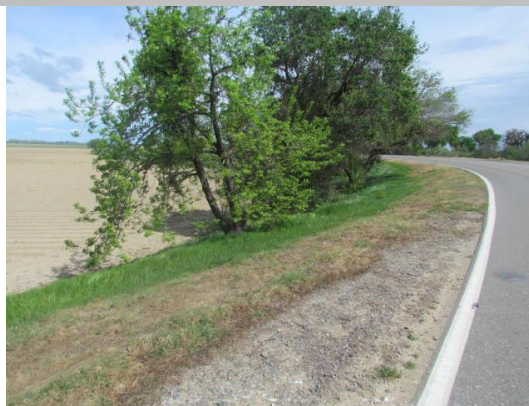
Photo 1 of 1 : SP_2018_RD0999_234_13_20180301_00013.jpg

Looking north at untrimmed trees on landward toe. (Spring 2015)

LM Start	1.57	Rating **	M	Issue No.	13
LM End	1.59	Issue Type +	Ma	Location *	LS
Category	Earthen Levee			GPS Latitude/Longitude	
				Start	End
Item	Trim / Thin Trees			38.306762 °	38.306948 °
				-121.598541 °	-121.598320 °
DWR ID	DWR_RD0999_03_s_2012_13				
Comment Code					
T3 : Trim and thin trees to allow visibility of the ground and room to flood fight.					
Inspector Comment

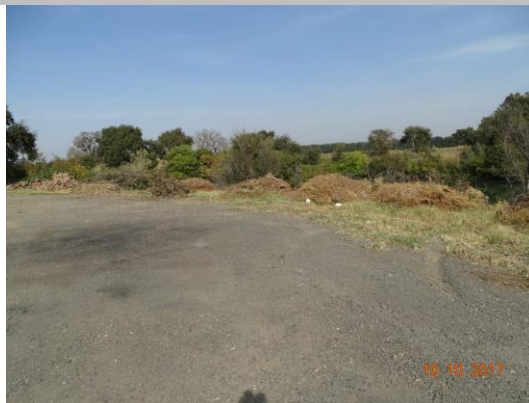
Photo 1 of 2 : SP_2018_RD0999_234_25_20180301_00024.jpg

LM Start	1.61	Rating **	M	Issue No.	25
LM End	1.61	Issue Type +	Ma	Location *	WS
Category	Earthen Levee			GPS Latitude/Longitude	
				Start	End
Item	Encroachments			38.307295 °	38.307295 °
				-121.598202 °	-121.598202 °
DWR ID	DWR_RD0999_03_s_2017_25				
Comment Code					
PR : Prunings					
Inspector Comment

View of waterside slope looking east.

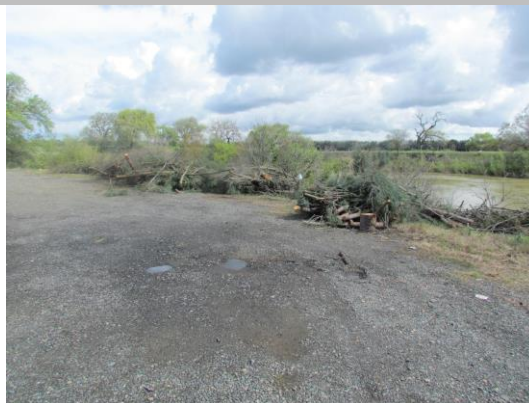
Photo 2 of 2 : SP_2018_RD0999_234_25_20180301_00025.jpg

LM Start	1.61	Rating **	M	Issue No.	25 (cont)	
LM End	1.61	Issue Type +	Ma	Location *	WS	
Category	Earthen Levee			GPS Latitude/Longitude		
				Start		End
Item	Encroachments			38.307295 °	38.307295 °	
				-121.598202 °	-121.598202 °	
DWR ID	DWR_RD0999_03_s_2017_25					
Comment Code						
PR : Prunings						
Inspector Comment

Looking east at several large pruning piles on waterward slope.

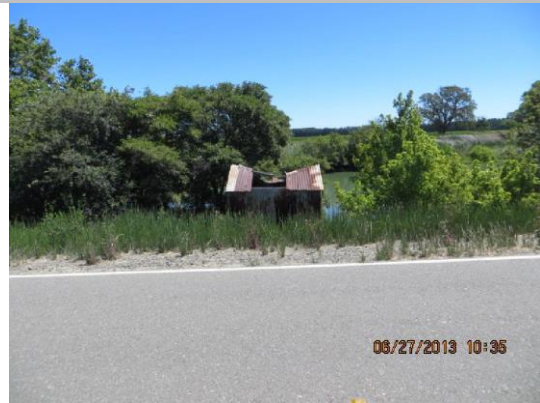
Photo 1 of 3 : UCIP_SP_2018_15392_25261.jpg

LM Start	1.71	Rating **	M	Issue No.	45	
LM End	1.71	Issue Type +	En	Location *		
Category	Supplemental			GPS Latitude/Longitude		
				Start	End	
Item	DWR UCIP Field Study			38.308513 °	38.308513 °	
				-121.598874 °	-121.598874 °	
DWR ID						
Comment Code						
Inspector Comment						
FS_ID:15392 DS_ID:22779 EP_NO: N/A Repair Type: Non-Urgent Crossing Status: Found UCIP Comments: Pipe abandoned and should be verified as being done so properly. FIELD_STRUCT_DESC: *ABANDONED* 5-inch steel irrigation pipe through the levee, 4.4 feet below the crown. Pump and valve in pump house on the waterside (WS) slope. Could not see the landside (LS) end of the pipe, February 1991. 1-inch galvanized iron electrical conduit at the same location. [Additional Reference(s): DWR Levee Log, 1992. USACE Sacramento O&M Manual 113 (Revised), October 1966, (HLM 1.71)]. FS Date: 6/27/2013

Pumphouse visible on WS slope.

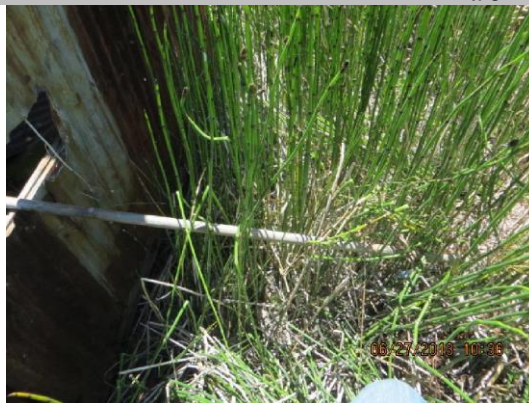
Photo 2 of 3 : UCIP_SP_2018_15392_25260.jpg

1-inch galvanized iron electrical conduit on WS slope.

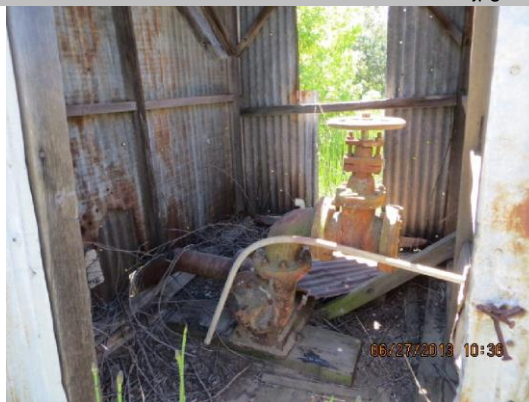
Photo 3 of 3 : UCIP_SP_2018_15392_25259.jpg

gatevalve inside pumphouse with no connection.

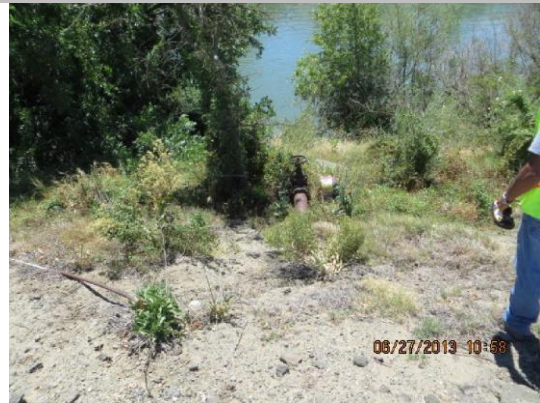
Photo 1 of 3 : UCIP_SP_2018_15393_25264.jpg

LM Start	2.00	Rating **	M	Issue No.	46
LM End	2.00	Issue Type +	En	Location *	
Category	Supplemental			GPS Latitude/Longitude	
				Start	End
Item	DWR UCIP Field Study			38.311709 °	38.311709 °
				-121.596713 °	-121.596713 °
DWR ID					
Comment Code					
Inspector Comment					
FS_ID:15393 DS_ID:22780 EP_NO: N/A Repair Type: Non-Urgent Crossing Status: Found UCIP Comments: Pipe abandoned and should be done so properly. FIELD_STRUCT_DESC: 7-inch steel irrigation pipe through the levee, 4.6 feet below the crown. Pump and gate valve on the waterside (WS) slope. Service pole on the landside (LS) slope. 1-inch galvanized iron electrical conduit at the same location. [Additional Reference(s): DWR Levee Log, 1992. USACE Sacramento O&M Manual 113 (Revised), October 1966, (HLM 2.01)]. FS Date: 6/27/2013

Pipe visible on WS slope.

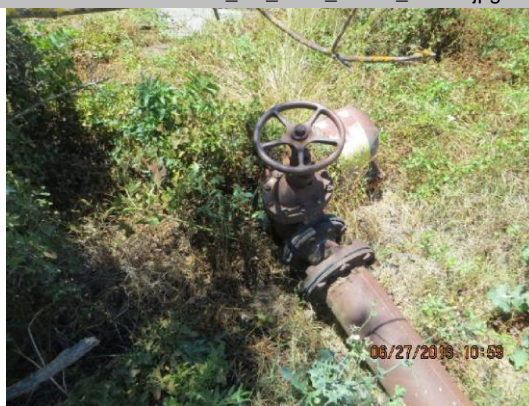
Photo 2 of 3 : UCIP_SP_2018_15393_25263.jpg

Gate valve on WS slope at pump.

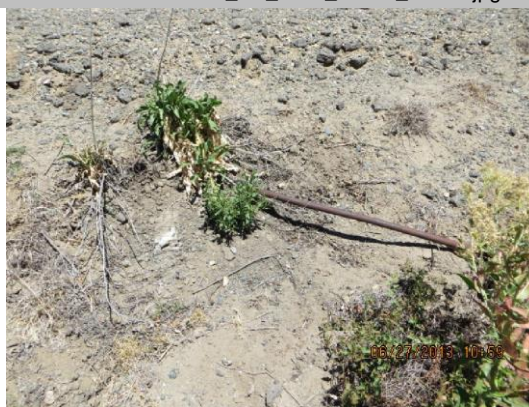
Photo 3 of 3 : UCIP_SP_2018_15393_25262.jpg

Galvanized iron pipe on WS slope.

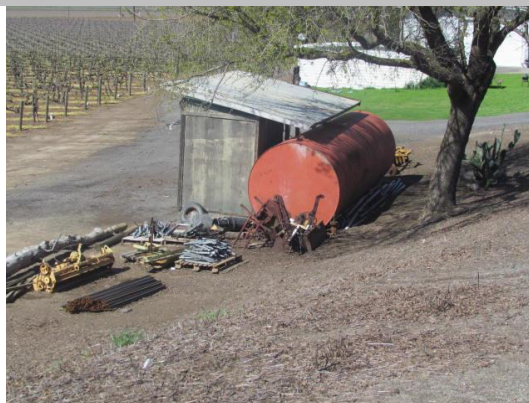
Photo 1 of 3 : SP_2018_RD0999_234_27_20180301_00026.jpg

LM Start	2.54	Rating **	U	Issue No.	27
LM End	2.54	Issue Type +	En	Location *	LS
Category	Earthen Levee			GPS Latitude/Longitude	
				Start	End
Item	Encroachments			38.317840 °	38.317840 °
				-121.590895 °	-121.590895 °
DWR ID	DWR_RD0999_03_s_2012_27				
Comment Code					
EQ : Equipment					
Inspector Comment					
Diesel tank stored at landside toe.

Looking northwest at diesel tank and other farm equipment stored at landside toe. (Spring 2016)

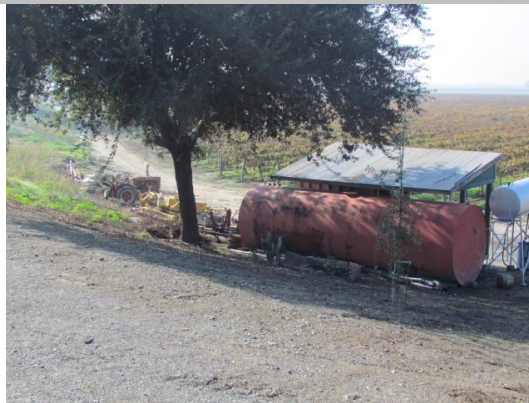
Photo 2 of 3 : SP_2018_RD0999_234_27_20180301_00027.jpg

Looking southwest at farm equipment stored at landside toe. (Fall Inspection 2012)

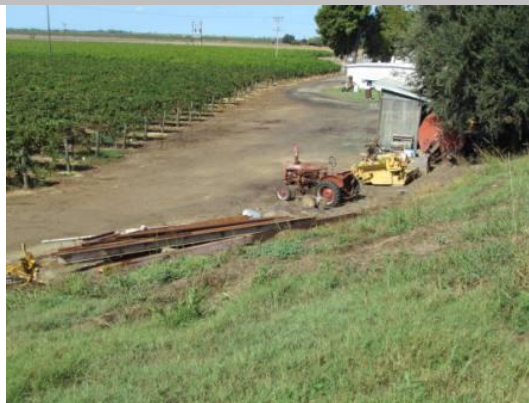
Photo 3 of 3 : SP_2018_RD0999_234_27_20180301_00028.jpg

LM Start	2.54	Rating **	U	Issue No.	27 (cont)	
LM End	2.54	Issue Type +	En	Location *	LS	
Category	Earthen Levee			GPS Latitude/Longitude		
				Start		End
Item	Encroachments			38.317840 °		38.317840 °
				-121.590895 °		-121.590895 °
DWR ID	DWR_RD0999_03_s_2012_27					
Comment Code						
EQ : Equipment						
Inspector Comment						
Diesel tank stored at landside toe.

Looking northwest at equipment at landside toe.

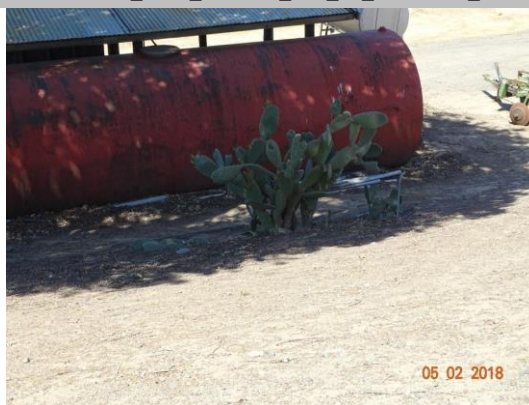
Photo 1 of 1 : SP_2018_RD0999_234_26_20180507_00052.jpg

LM Start	2.56	Rating **	M	Issue No.	26
LM End	2.56	Issue Type +	En	Location *	LS
Category	Earthen Levee			GPS Latitude/Longitude	
				Start	End
Item	Vegetation			38.318073 °	38.318073 °
				-121.590818 °	-121.590818 °
DWR ID	DWR_RD0999_03_s_2018_26				
Comment Code					
V6 : Landscaping					
Inspector Comment					
Cactus at landside toe.

Vegetation landside toe looking west.

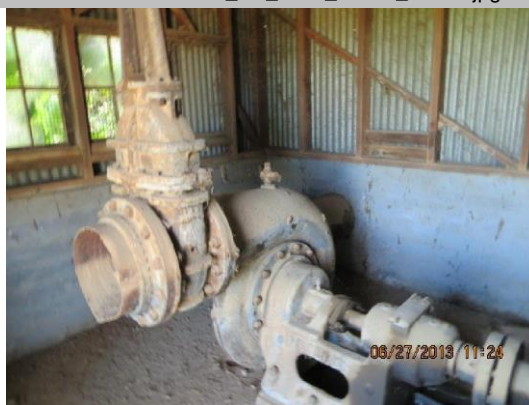
Photo 2 of 3 : UCIP_SP_2018_15406_25284.jpg

Pump and gatevalve inside pumphouse at LS toe.

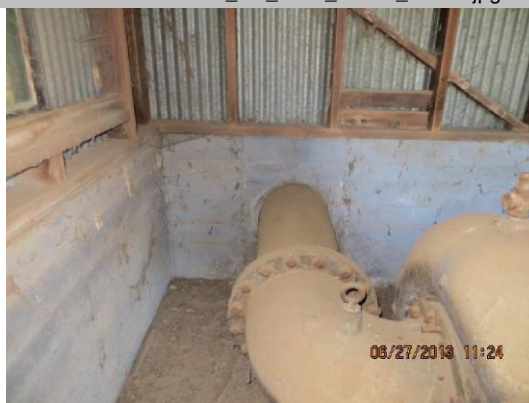
Photo 3 of 3 : UCIP_SP_2018_15406_25283.jpg

LM Start	2.88	Rating **	M	Issue No.	47 (cont)	
LM End	2.88	Issue Type +	En	Location *		
Category	Supplemental			GPS Latitude/Longitude		
				Start		End
Item	DWR UCIP Field Study			38.322652 °		38.322652 °
				-121.590841 °		-121.590841 °
DWR ID						
Comment Code						
Inspector Comment						
FS_ID:15406 DS_ID:22782 EP_NO: N/A Repair Type: Non-Urgent Crossing Status: Found UCIP Comments: This pipe is abandoned and should be done so properly. FIELD_STRUCT_DESC: *ABANDONED* 16-inch steel drainage pipe through the levee, 9.3 feet below the crown. Pump and gate valve in pump house on the landside (LS) slope. [Additional Reference(s): DWR Levee Log, 1992. USACE Sacramento O&M Manual 113 (Revised), October 1966, (HLM 2.91)]. FS Date: 6/27/2013

Pipe entering levee at LS toe.

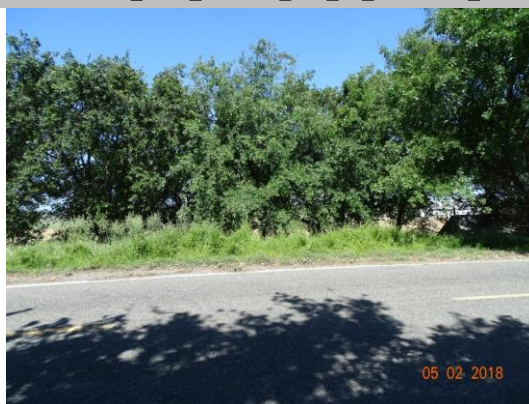
Photo 1 of 2 : SP_2018_RD0999_234_10_20180507_00053.jpg

LM Start	2.88	Rating **	U	Issue No.	10
LM End	2.88	Issue Type +	Ma	Location *	LS
Category	Earthen Levee			GPS Latitude/Longitude	
				Start	End
Item	Trim / Thin Trees			38.322757 °	38.322757 °
				-121.590817 °	-121.590817 °
DWR ID	DWR_RD0999_03_f_2012_10				
Comment Code					
T3 : Trim and thin trees to allow visibility of the ground and room to flood fight.					
Inspector Comment					
Wild growth at landside slope and toe.

Trim thin trees landside looking west.

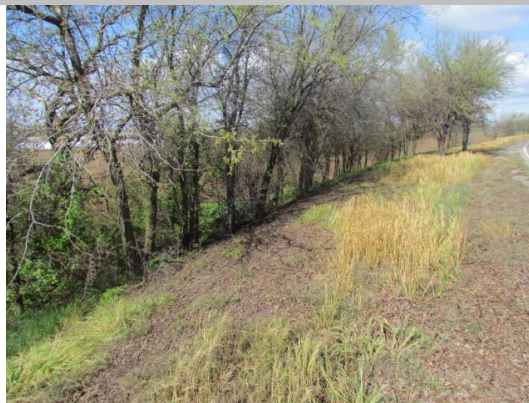
Photo 2 of 2 : SP_2018_RD0999_234_10_20180301_00006.jpg

LM Start	2.88	Rating **	U	Issue No.	10 (cont)	
LM End	2.88	Issue Type +	Ma	Location *	LS	
Category	Earthen Levee			GPS Latitude/Longitude		
				Start		End
Item	Trim / Thin Trees			38.322757 °		38.322757 °
				-121.590817 °		-121.590817 °
DWR ID	DWR_RD0999_03_f_2012_10					
Comment Code						
T3 : Trim and thin trees to allow visibility of the ground and room to flood fight.						
Inspector Comment						
Wild growth at landside slope and toe.

Looking northwest at dense vegetation on landward slope and toe.
(Spring 2016)

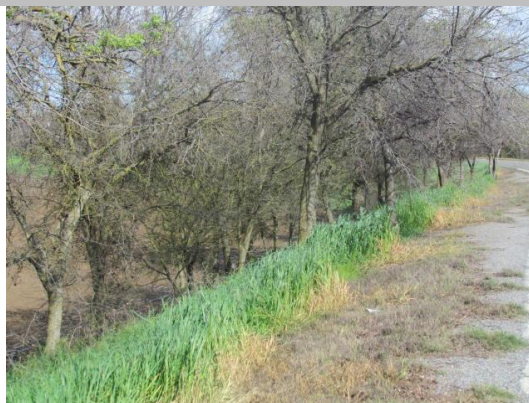
Photo 1 of 2 : SP_2018_RD0999_234_31_20180301_00031.jpg

Looking northwest at untrimmed trees on landward slope. (Spring 2016)

LM Start	3.02	Rating **	U	Issue No.	31
LM End	3.08	Issue Type +	Ma	Location *	LS
Category	Earthen Levee			GPS Latitude/Longitude	
				Start	End
Item	Trim / Thin Trees			38.323832 °	38.324031 °
				-121.588736 °	-121.587763 °
DWR ID	DWR_RD0999_03_s_2012_31				
Comment Code					
T3 : Trim and thin trees to allow visibility of the ground and room to flood fight.					
Inspector Comment

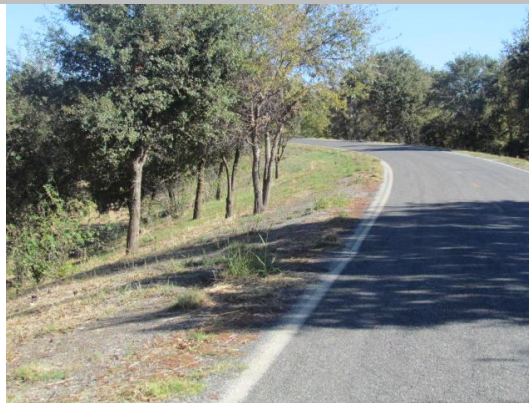
Photo 2 of 2 : SP_2018_RD0999_234_31_20180301_00032.jpg

Looking north at trimmed trees on landward slope.

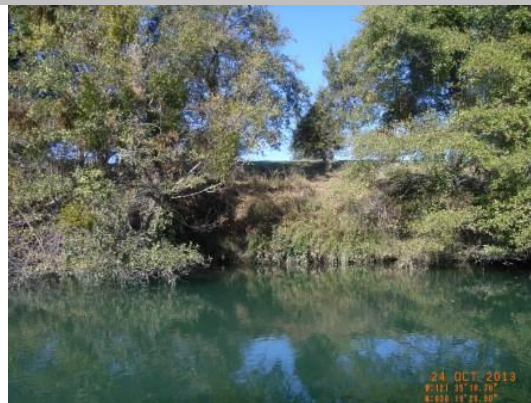
Photo 1 of 1 : SP_2018_RD0999_234_5_20180301_00002.jpg

LM Start	3.05	Rating **	A/W	Issue No.	5
LM End	3.23	Issue Type +	Ma	Location *	WS
Category	Supplemental			GPS Latitude/Longitude	
				Start	End
Item	2015 USACE Erosion Survey, DRAFT			38.323667 °	38.325592 °
				-121.588226 °	-121.585925 °
DWR ID	DWR_RD0999_03_s_2016_5				
Comment Code					
Inspector Comment					
2011 - Multiple erosion pockets. Some likely from tree popouts. 2013 - Tall vertical sections. 2015: New tree popout and significant new erosion. [2015 Site ID: STR_27-3_R]

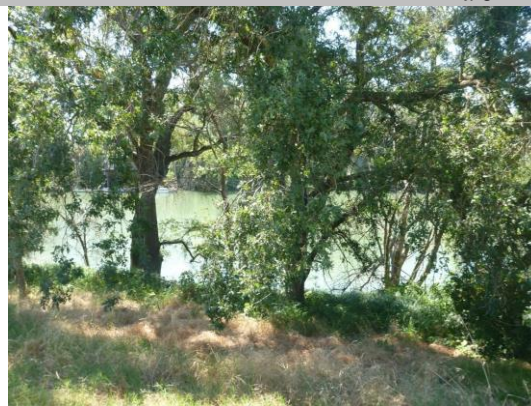
Photo 1 of 3 : LEVAL_SP_2018_355_2523.jpg

LM Start	3.09	Rating **	A/W	Issue No.	9
LM End	3.12	Issue Type +	Ma	Location *	
Category	Supplemental			GPS Latitude/Longitude	
				Start	End
Item	2017 Storm Damage			38.323986 °	38.324275 °
				-121.587403 °	-121.586967 °
DWR ID	DWR_RD0999_03_f_2017_9				
Comment Code					
Inspector Comment					
Levee Evaluation Comments					
Description:The damage consists of erosion of the lower waterside levee slope and bank approximately 147 feet in length along the west (right) bank of Sutter Slough. See attached pages for photos. Site location T06N R03E Section 36 and 25.					
Site ID No:355					
Site Designation:LMA-182					
Repair Type: Erosion					
Rating:Area of Concern					
Field Date:7/27/2017					
Notes:

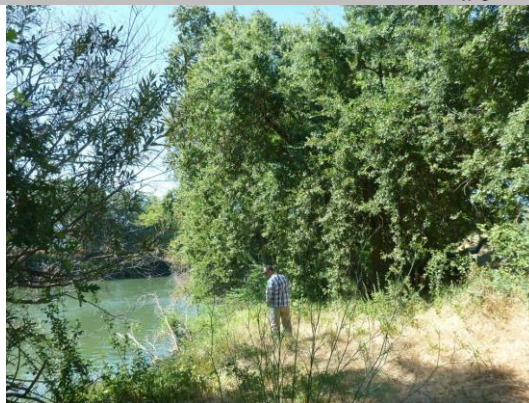
Photo 1 of 3 : LEVAL_SP_2018_356_2492.jpg

LM Start	3.18	Rating **	A/W	Issue No.	15
LM End	3.21	Issue Type +	Ma	Location *	
Category	Supplemental			GPS Latitude/Longitude	
				Start	End
Item	2017 Storm Damage			38.325053 °	38.325489 °
				-121.586347 °	-121.586100 °
DWR ID	DWR_RD0999_03_f_2017_15				
Comment Code					
Inspector Comment					
Levee Evaluation Comments					
Description:The damage consists of erosion of the lower waterside levee slope and bank approximately 172 feet in length along the west (right) bank of Sutter Slough. See attached pages for photos. Site location T06N R04E Section 3 and 4.					
Site ID No:356					
Site Designation:LMA-183					
Repair Type: Erosion					
Rating:Area of Concern					
Field Date:7/27/2017					
Notes:

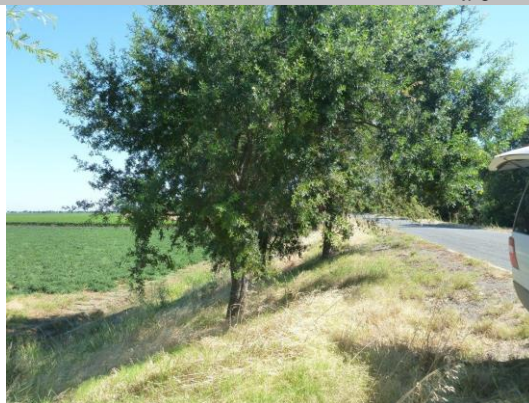
Photo 3 of 3 : LEVAL_SP_2018_356_2499.jpg

LM Start	3.18	Rating **	A/W	Issue No.	15 (cont)	
LM End	3.21	Issue Type +	Ma	Location *		
Category	Supplemental			GPS Latitude/Longitude		
				Start	End	
Item	2017 Storm Damage			38.325053 °	38.325489 °	
				-121.586347 °	-121.586100 °	
DWR ID	DWR_RD0999_03_f_2017_15					
Comment Code						
Inspector Comment						
Levee Evaluation Comments						
Description:The damage consists of erosion of the lower waterside levee slope and bank approximately 172 feet in length along the west (right) bank of Sutter Slough. See attached pages for photos. Site location T06N R04E Section 3 and 4.						
Site ID No:356						
Site Designation:LMA-183						
Repair Type: Erosion						
Rating:Area of Concern						
Field Date:7/27/2017						
Notes:

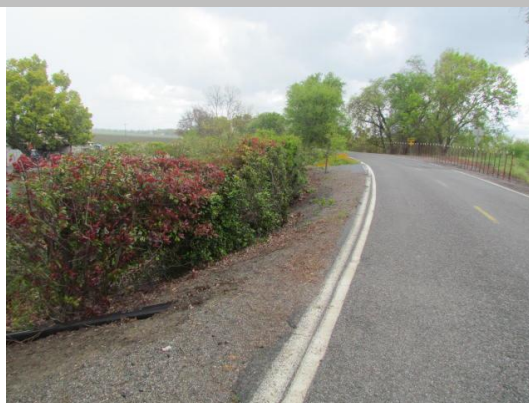
Photo 1 of 2 : SP_2018_RD0999_234_22_20180301_00021.jpg

LM Start	3.69	Rating **	U	Issue No.	22
LM End	3.71	Issue Type +	En	Location *	LS
Category	Earthen Levee			GPS Latitude/Longitude	
				Start	End
Item	Vegetation			38.331969 °	38.332156 °
				-121.584860 °	-121.584707 °
DWR ID	DWR_RD0999_03_s_2012_22				
Comment Code					
V6 : Landscaping					
Inspector Comment

Looking southwest at trimmed landscaping on landside slope, but still blocking levee slope.

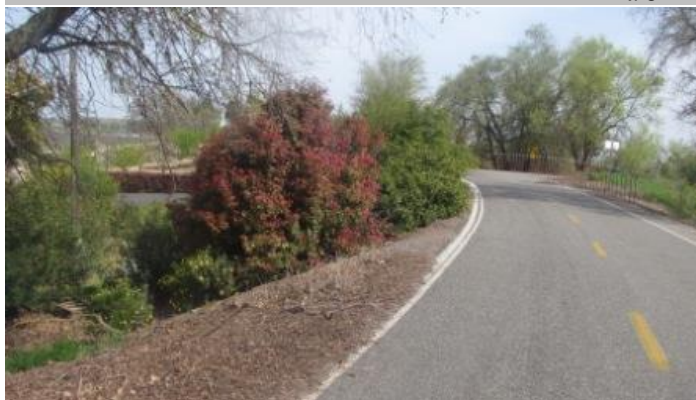
Photo 2 of 2 : SP_2018_RD0999_234_22_20180301_00022.jpg

LM Start	3.69	Rating **	U	Issue No.	22 (cont)	
LM End	3.71	Issue Type +	En	Location *	LS	
Category	Earthen Levee			GPS Latitude/Longitude		
				Start		End
Item	Vegetation			38.331969 °		38.332156 °
				-121.584860 °		-121.584707 °
DWR ID	DWR_RD0999_03_s_2012_22					
Comment Code						
V6 : Landscaping						
Inspector Comment

Looking northwest at landscaping on landside slope and toe. (Spring 2011)

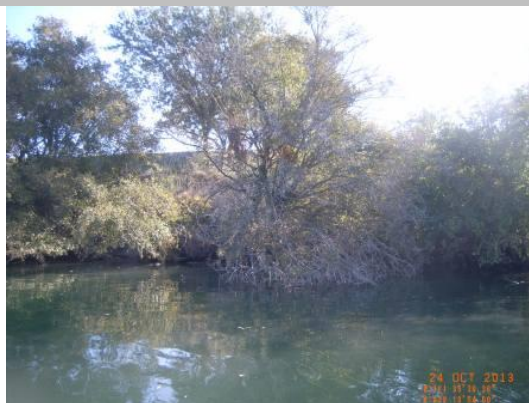
Photo 1 of 1 : SP_2018_RD0999_234_18_20180301_00019.jpg

LM Start	4.56	Rating **	M	Issue No.	18
LM End	4.68	Issue Type +	Ma	Location *	WS
Category	Supplemental			GPS Latitude/Longitude	
				Start	End
Item	2015 USACE Erosion Survey, DRAFT			38.313836 °	38.315407 °
				-121.592259 °	-121.591433 °
DWR ID	DWR_RD0999_03_s_2016_18				
Comment Code					
Inspector Comment					
2002 - Original rock over geotextile is sliding off and the end is coming unraveled. 2003 - Some minor new erosion on the downstream end. 2004 - Site has gotten worse. Underlined geofabric is exposed. 2005 - Still looks bad with exposed geotextile fabric. 2006 - Still have some new unraveling and exposed fabric. Site lengthened upstream. 2009 - Minimal new erosion. 2010 - geotextile fabric placed since last year, possible flood fight. 2012 - Exposed geotech style fabric, assume rock on top slid off. 2015: Erosion pockets covered with plastic. [2015 Site ID: STR_26-5_L]

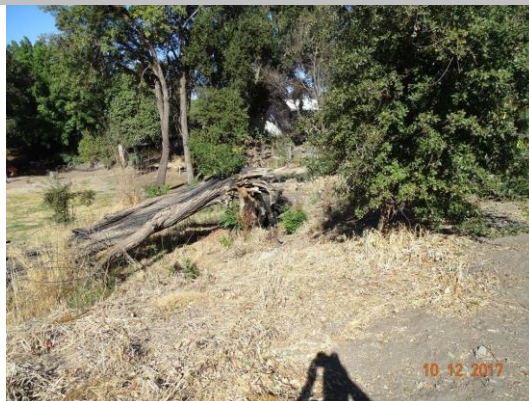
Photo 1 of 2 : SP_2018_RD0999_235_45_20180301_00034.jpg

LM Start	0.03	Rating **	M	Issue No.	45
LM End	0.03	Issue Type +	Ma	Location *	LS
Category	Earthen Levee			GPS Latitude/Longitude	
				Start	End
Item	Encroachments			38.414335 °	38.414335 °
				-121.523348 °	-121.523348 °
DWR ID	DWR_RD0999_04_s_2017_45				
Comment Code					
TR : Tree or limb					
Inspector Comment					
Large downed tree on landside slope.

Looking northwest at the landside slope.
